EXHIBIT C

Investigative Report
148 Gansett Road
Woods Hole, MA 02543
Date of Loss: 01/21/03
By: Joseph Folger, IAAI-CFI and
Thomas J. Klem, Fire Protection Engineer, IAAI-CFI
September 19, 2004

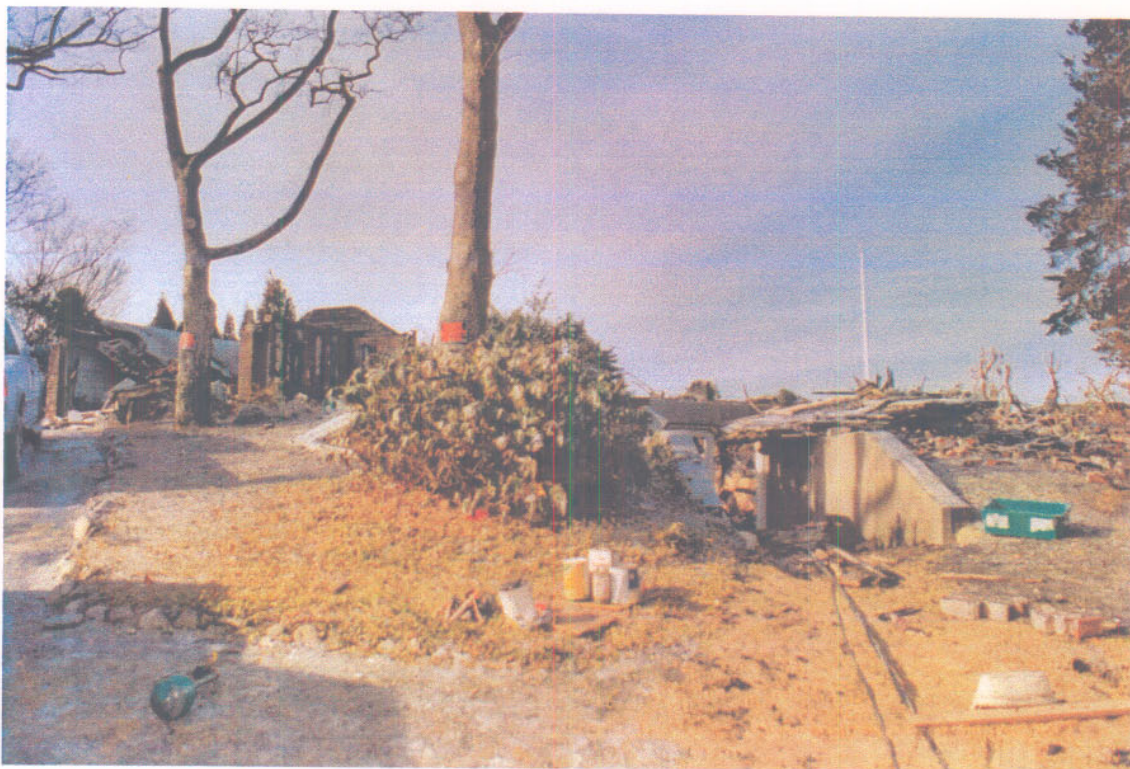
Approach to the home along its driveway from Gansett Road.

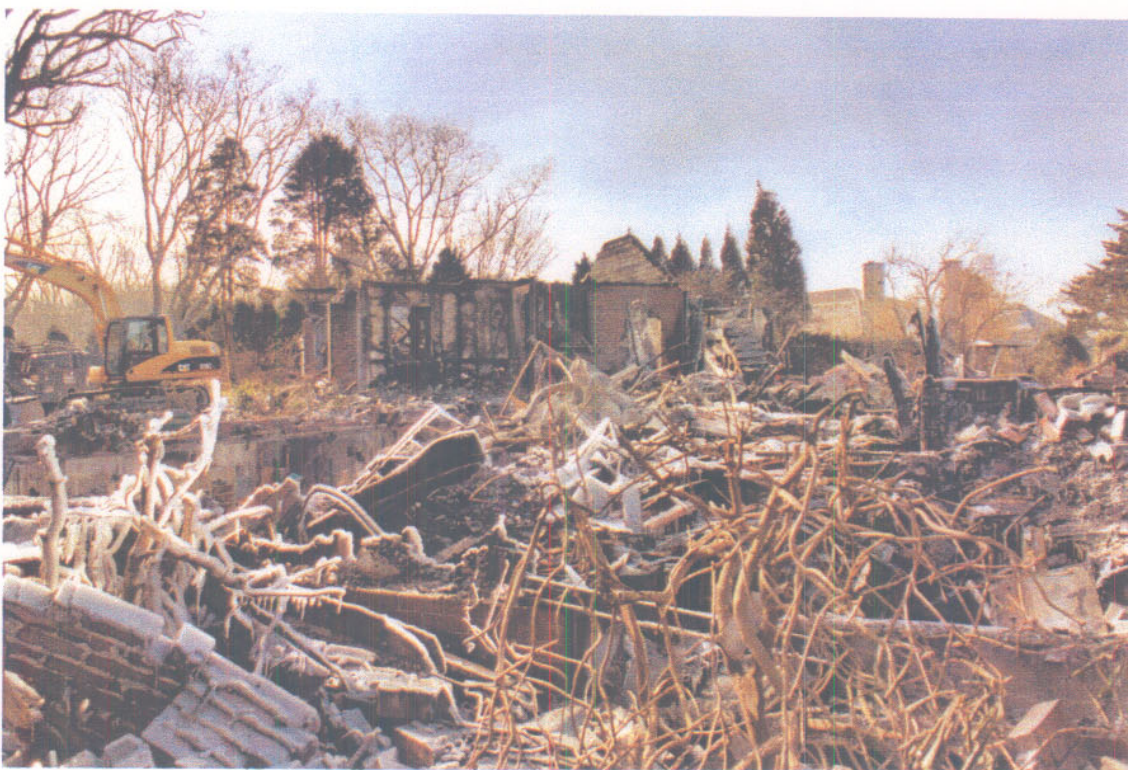
General conditions found by our investigators.

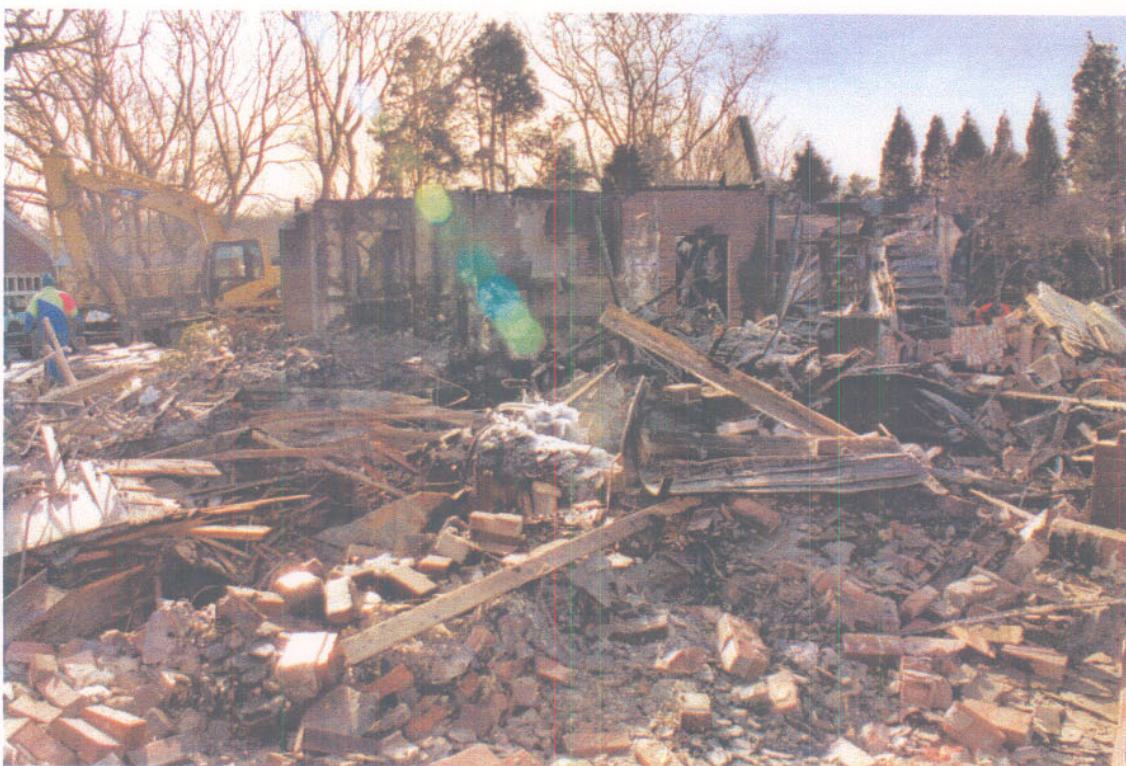
An additional view of the destruction of the home.

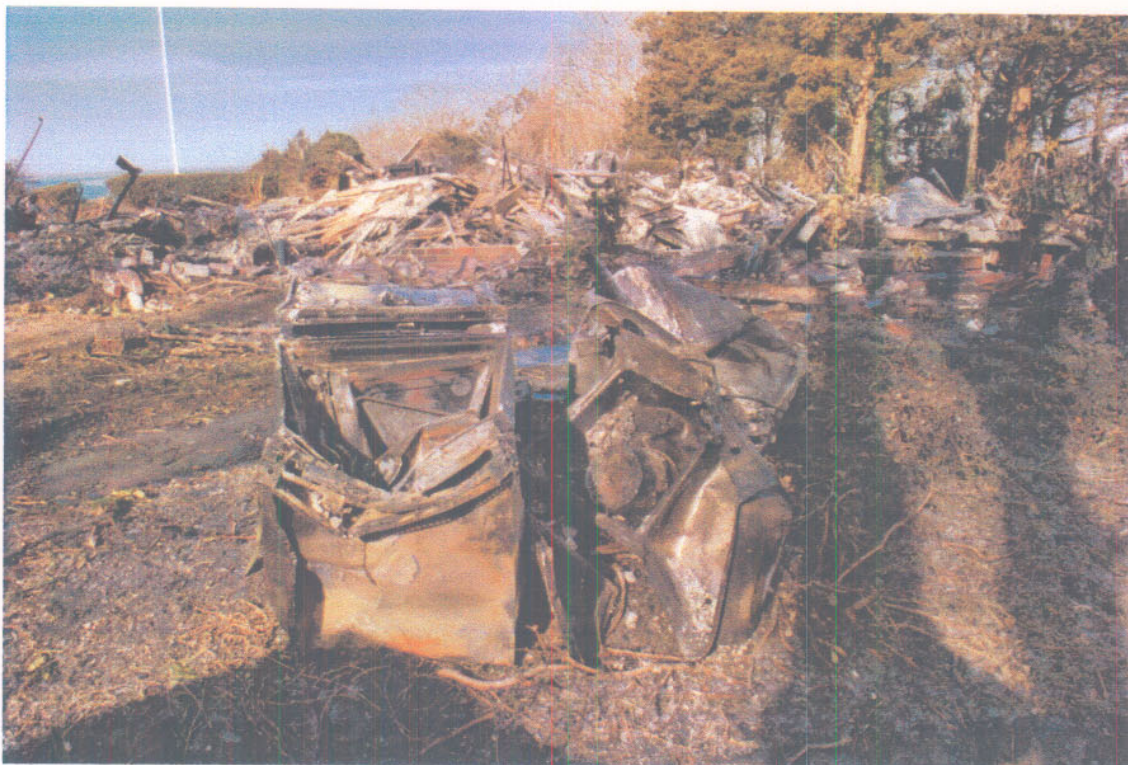
Our investigators examined these and other appliances, etc. from the home.

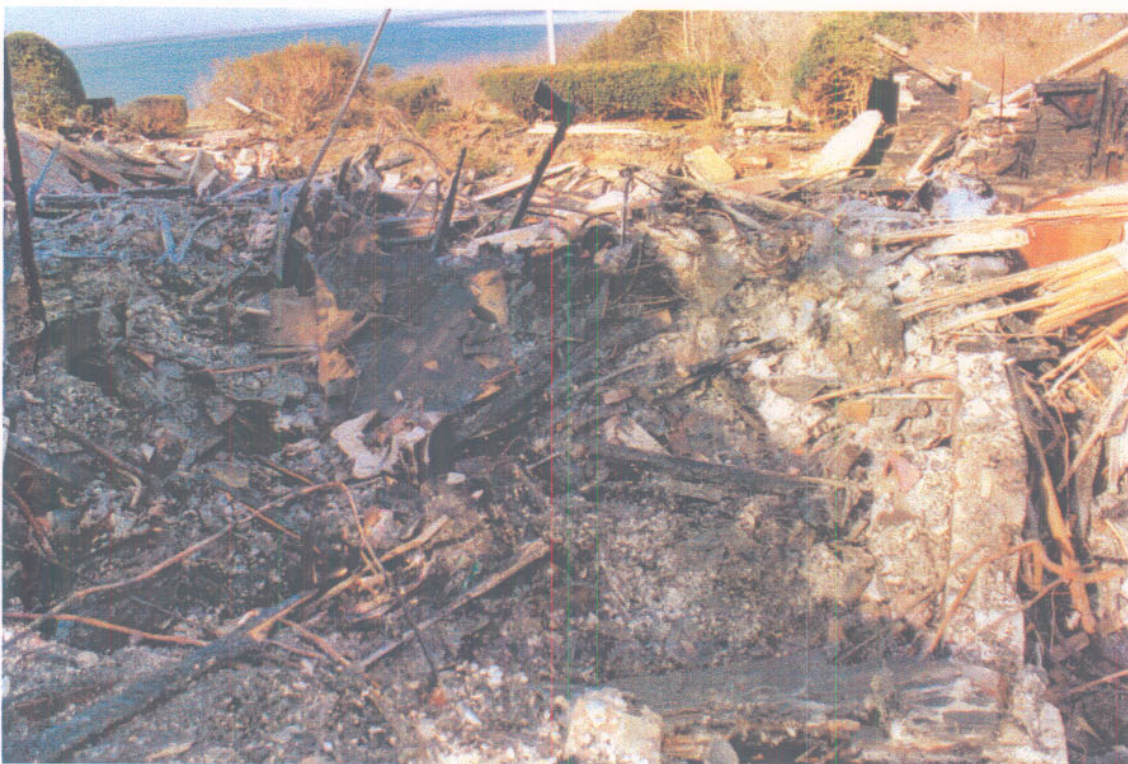
Remains of the kitchen area.

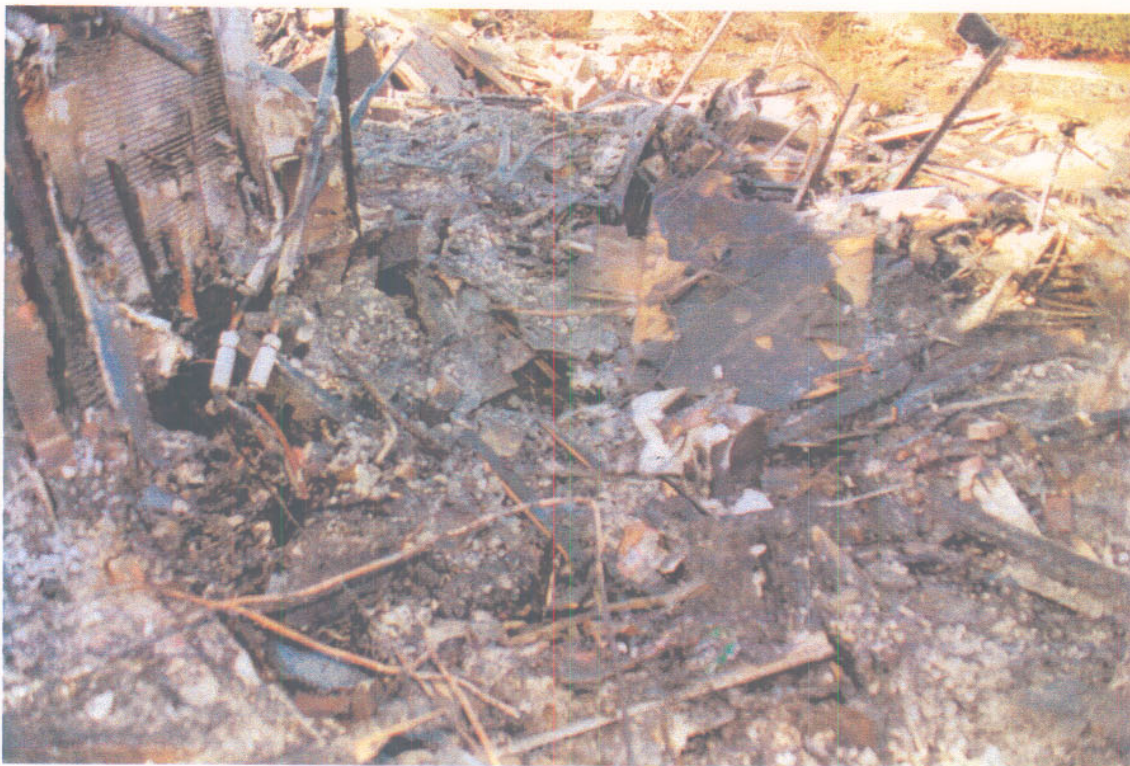
Another view of the kitchen area.

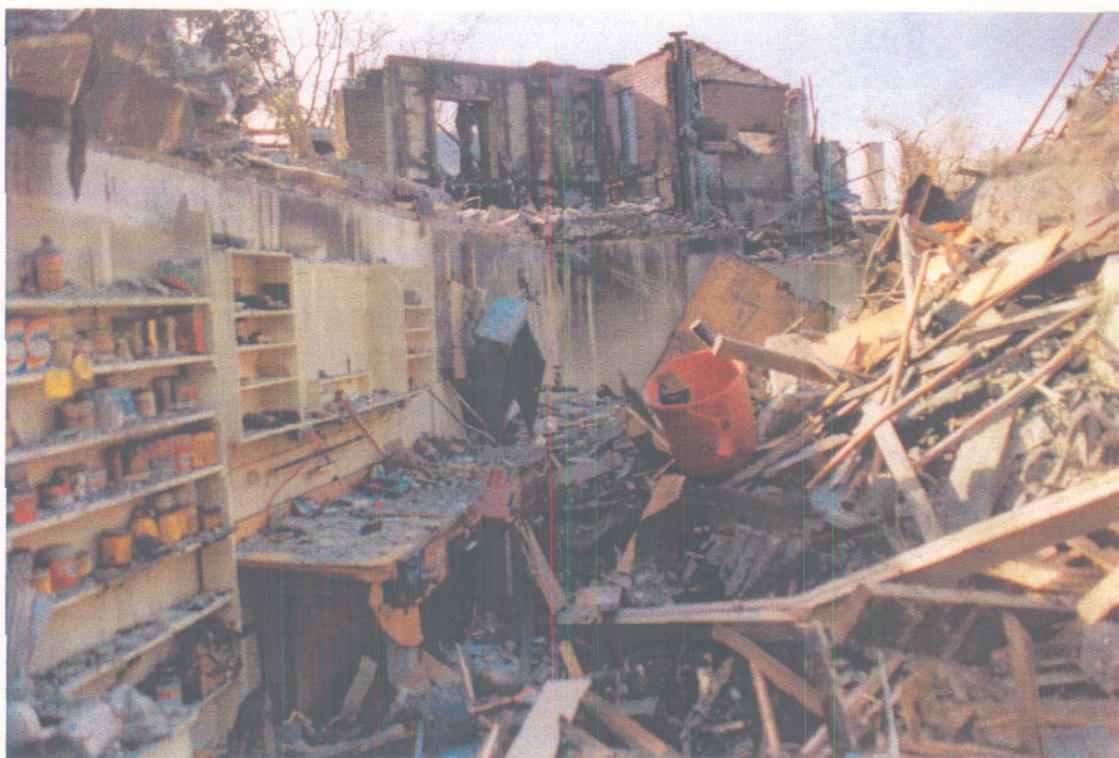
Basement area of the home indicates that it was not the level of fire origin.

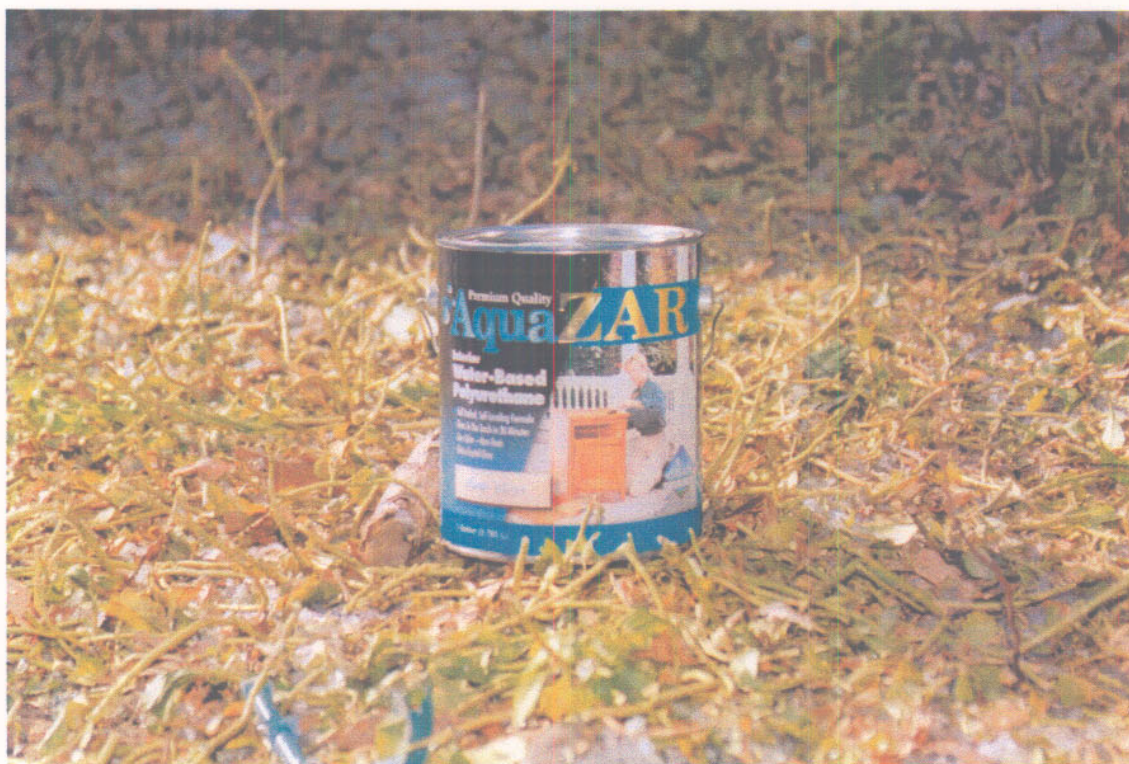
cabinets was non-combustible and was identified as Premium Quality Aqua Zar, a water-based polyurethane. Thus this material on rags, etc. is not susceptible to spontaneous combustion.

Exemplar material being used to refinish the kitchen cabinets.

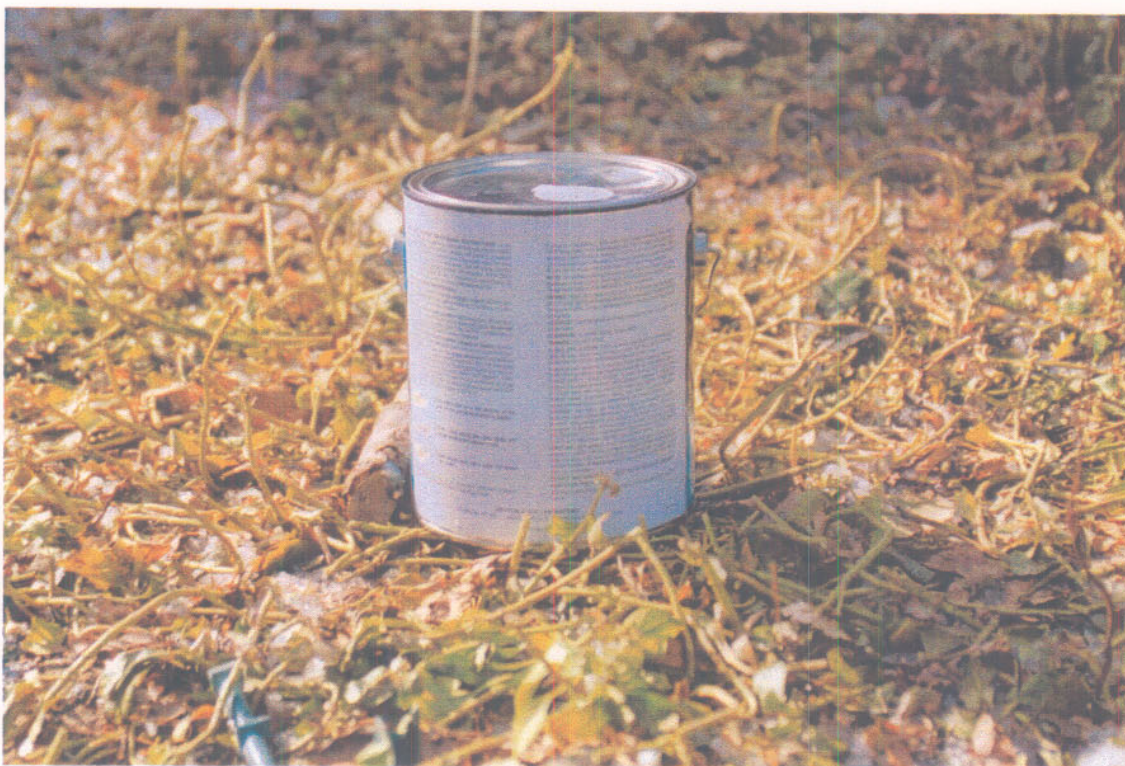
The material was determined not to be susceptible to spontaneous combustion.

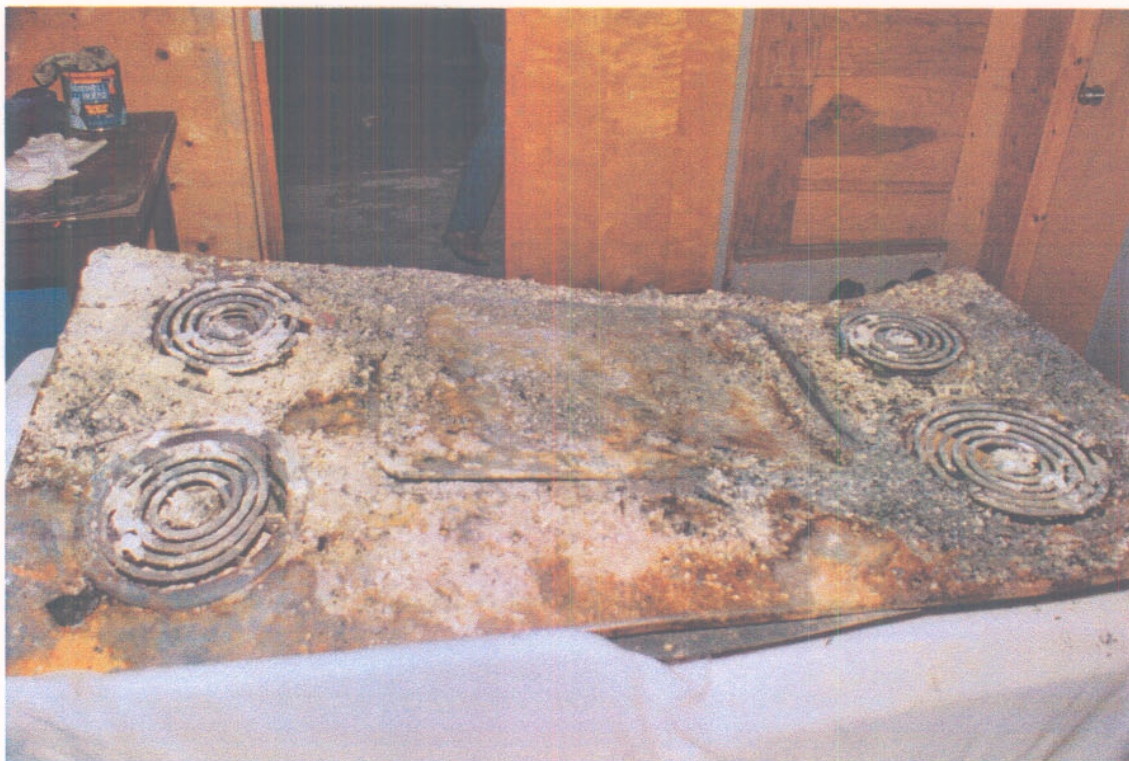
After the interview with Mr. Vose investigators Folger and Klem met with Deputy Rogers at the Falmouth Fire Station where the cooktop was located. The cooktop appliance was identified as Thermador, 5551 McFadden Avenue, Huntington Beach, CA 92649. Examination of the cooktop revealed that the plastic-type control knobs were melted off but close examination of the metal control stems showed that one of the stems was turned to the "on" position.

Examination of the stovetop at fire department headquarters.

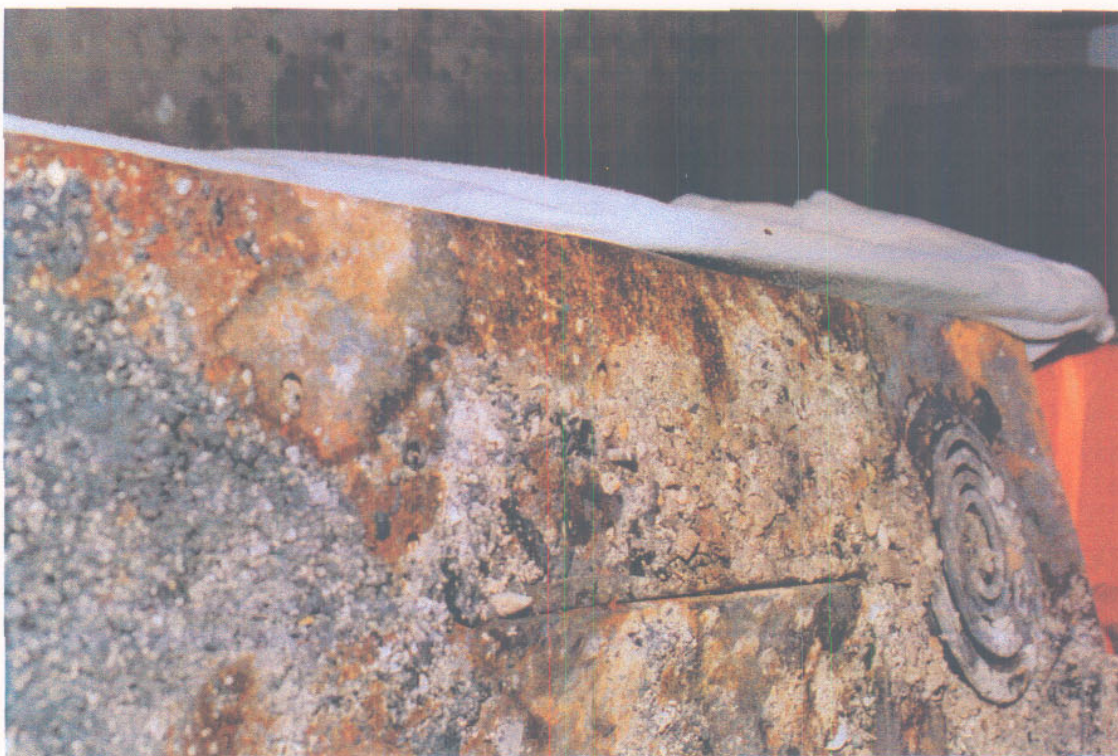
The ignition scenario for this fire determined by our investigators to be the ignition the wooden cabinet component that had been placed on the electric stove's countertop. The evidence established in this case determined that one of the surface burners was in the "on" position leading to the smoldering ignition of the wood-cabinet material and its contents. Prolonged smoldering of the fire continued undetected until some time before the automatic low temperature alarm was received by the monitoring company, Intercity alarms and the phone call and assessment by Mr. Vose determined that a severe, advanced fire was present within the kitchen area of the MacNeil home. From a fire protection perspective, this is an unusual sequencing of alarm notification and the lack of early detection of the fire within a controllable state has been determined to be a significant factor in our analysis of this fire incident.

Our examination determined that one of the control knobs was in the "on" position.
